Owners Update: February 8, 2021

Water Project Progress Report:

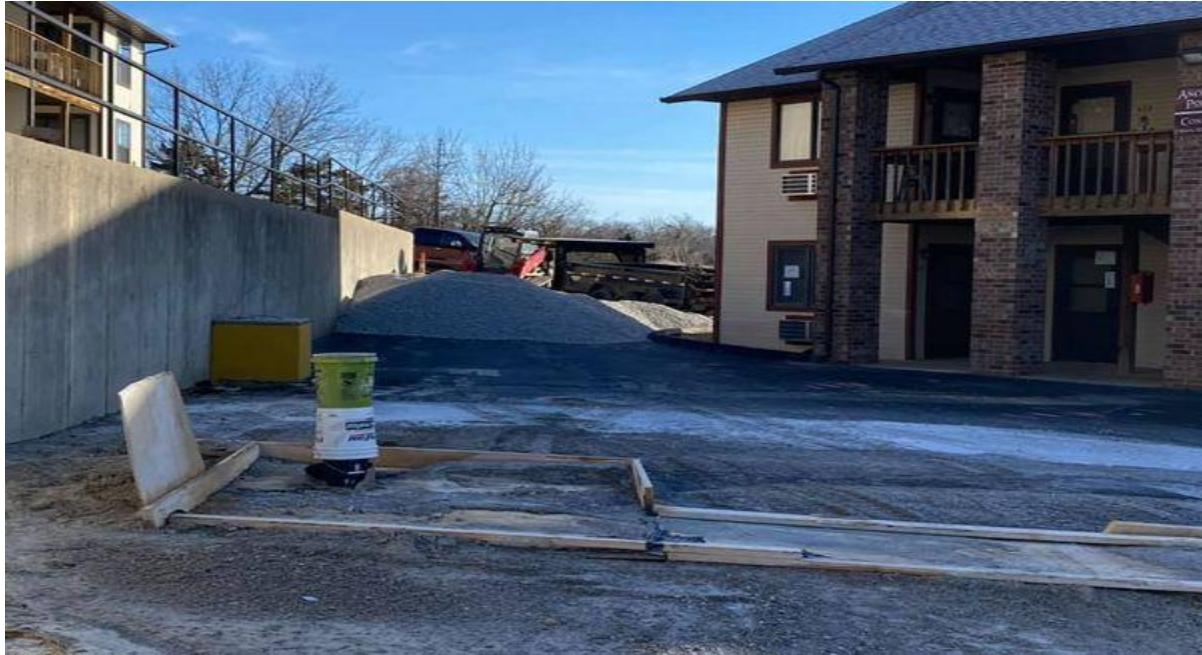
AmeriPride Industries has completed the Retaining Wall and Rock Foundation. The expanded and reinforced surface area will support the Water Tank and Well House of the water system. The area was excavated to bedrock and 96 tons of rock was used to fill the recovered area.

The pictures attached are from owners. One shows the retaining wall that will support the tank and well house. The second picture shows a pile of gravel, but in the foreground is the top of the well, hidden under an inverted bucket and a green bucket. This wellhead will be finished, and some large stones or concrete blocks will be placed around it to prevent it being damaged in the parking lot. The wood sluiceway shown in the picture has since been removed during the parking lot clean up.

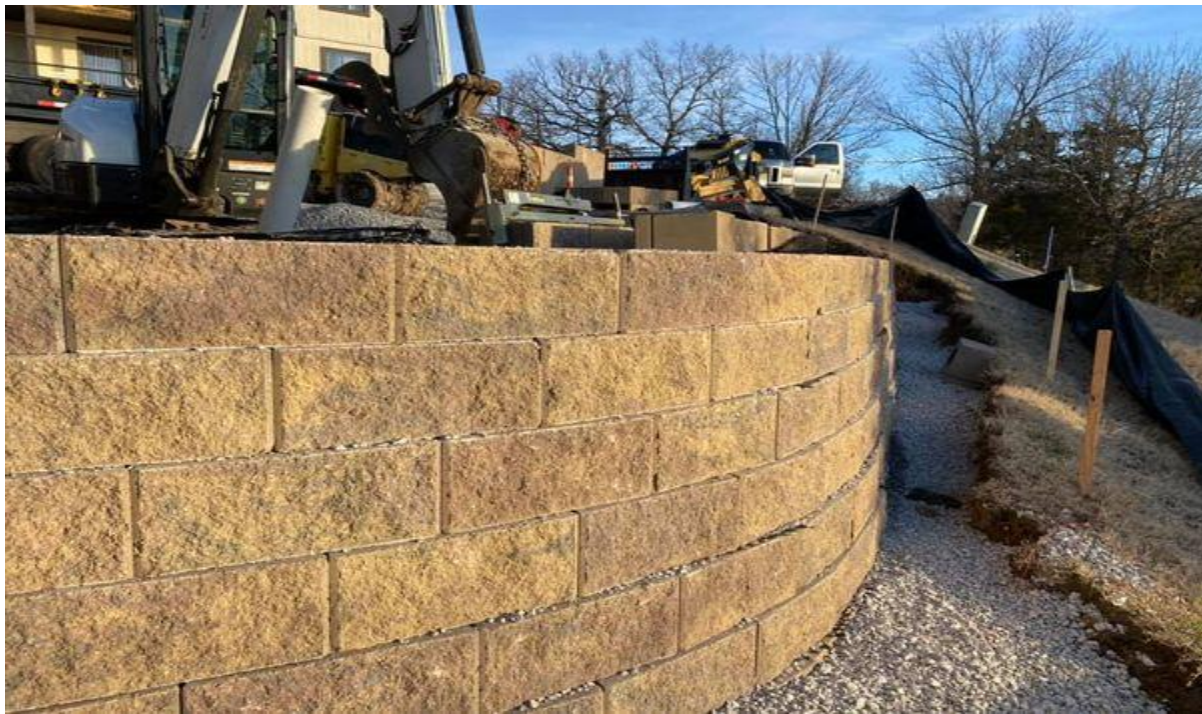
The depth of the well is 615 feet with steel casing and grout to a depth of 396 feet. The water flow from the well is 115 gallons per minute. The Department of Natural Resources has approved the casing and grouting. We expect their overall approval of the entire well once they complete testing of samples from 400 feet to 615 feet.
